Electronic Supplement to

Earthquake Damage and Repair: New Evidence from Jerusalem on the 1927 Jericho Earthquake

By Motti Zohar, Rehav Rubin and Amos Salamon

Examples from Jaffa Gate area

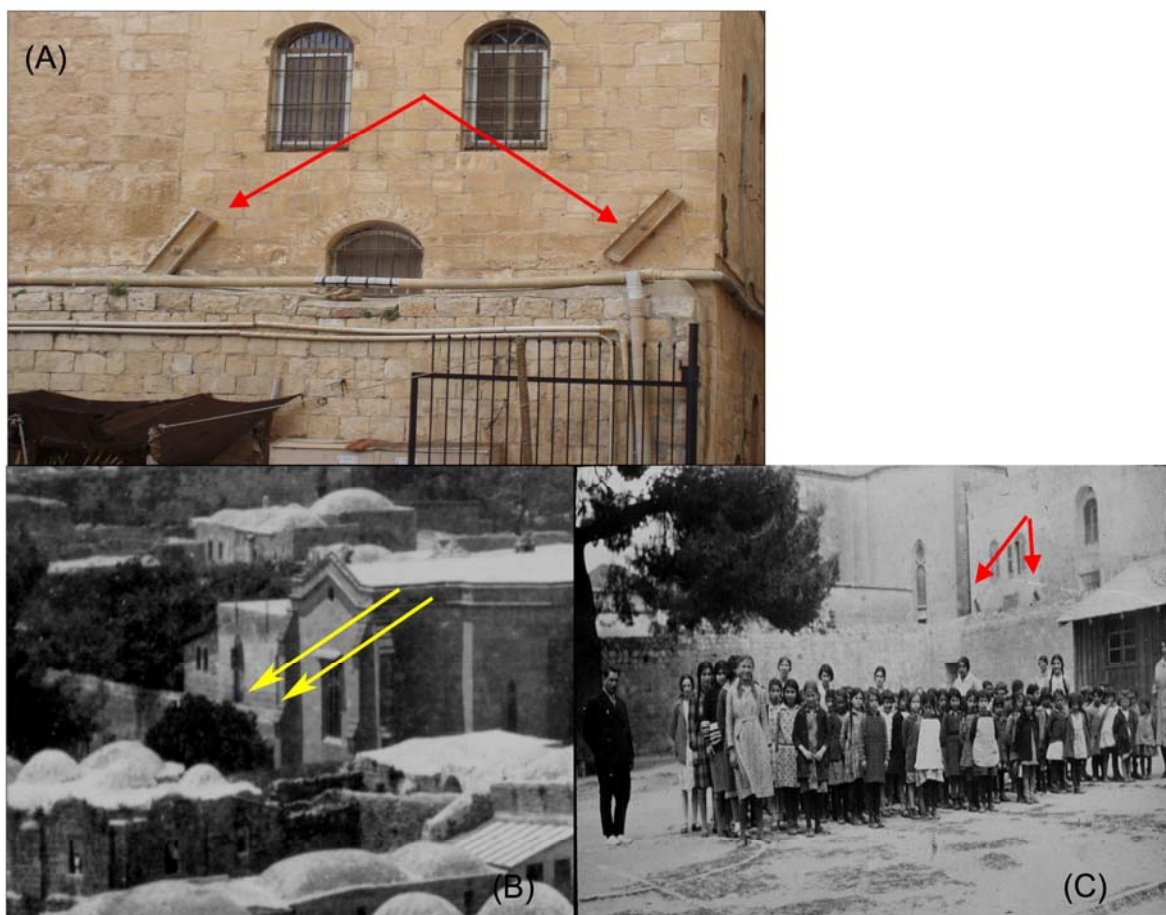
Figure S1

Figure S1: Eastern wall of the Alexander building, Christ Church complex: (A) two massive iron rails facing east (April 2011); (B) a part of an aerial photograph by Bruno Hentschel taken in 1898 from the tower of the Church of the Redeemer (source: Hentschel, B., Panoramic view, Church of the Redeemer, Jerusalem, Leipzig: Yeri Rimon collection, 1898 B. VIII). No anchor is evident (their expected locations are marked by a yellow arrows); (C) back yard of the Alexander building, late 30's (source: Anonymous, Christ Church: back yard of the Alexander building, Jerusalem: Conrad Schick Library, 1930-1940).

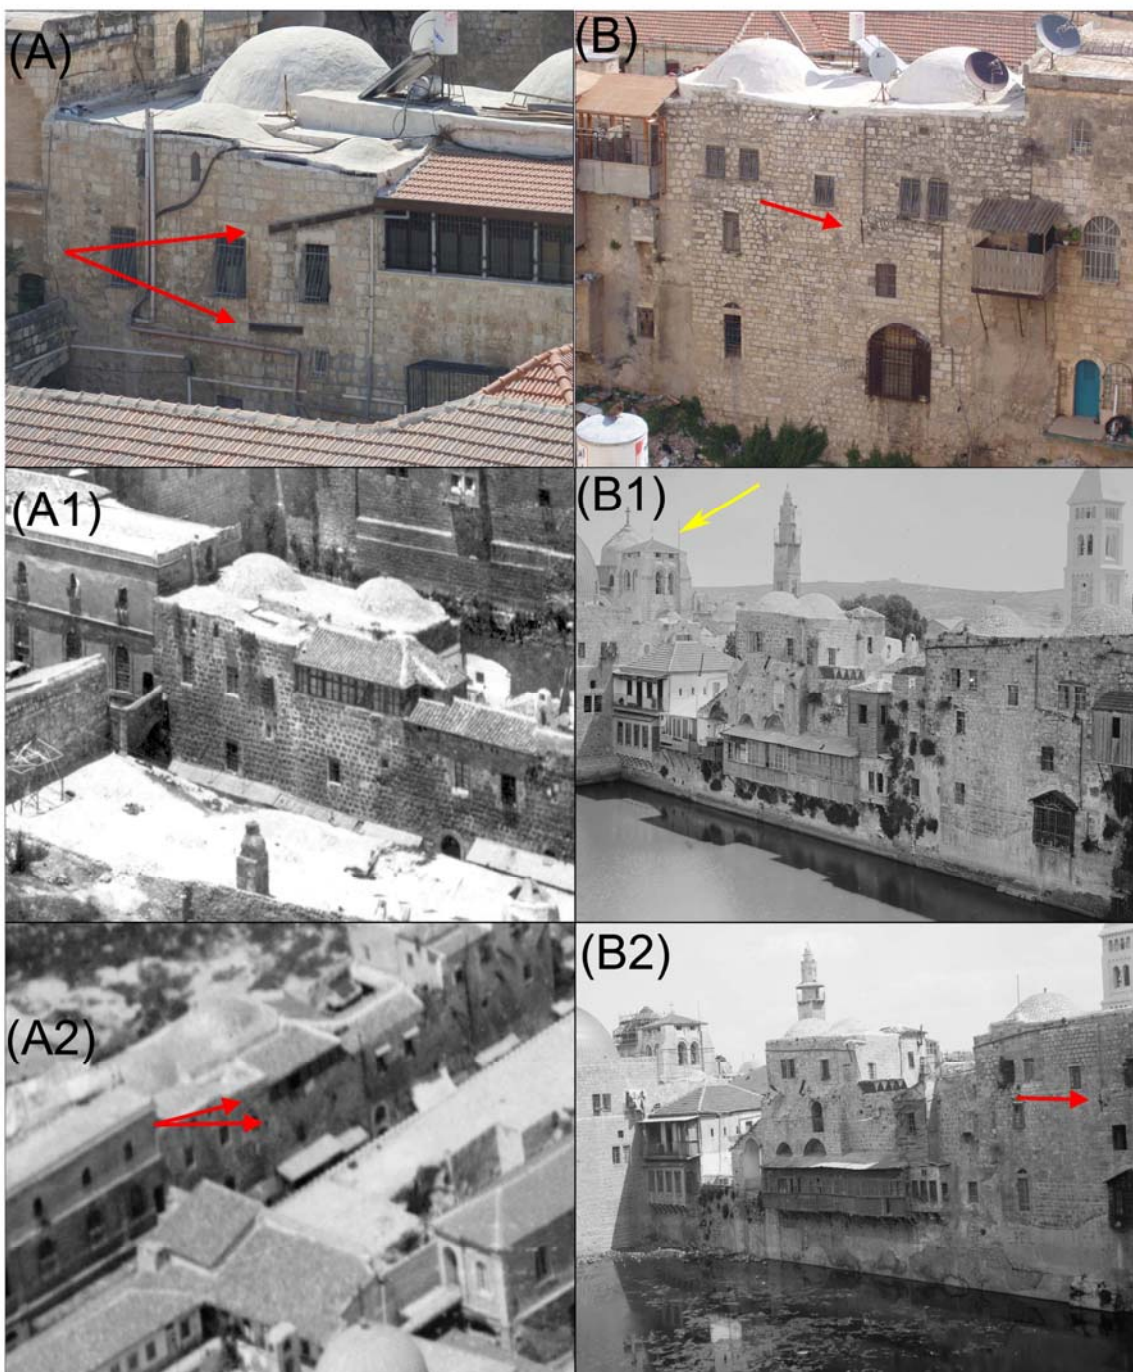
Figure S2

Figure S2: Massive iron rails, above a building at the Avtimus and Patriarch corner: (A) from the top of the Church of the Redeemer (August 2011); (A1) old photograph from 1898 (source: Hentschel, B., Panoramic view, Church of the Redeemer, Jerusalem, Leipzig: Yeri Rimon collection, 1898 B. VIII). The building's wall is anchor free; (A2) air photo from 1931 (source: American Colony Photograph Department, Jerusalem from the air (Old City), Jerusalem: G. Eric and Edith Matson Photograph Collection, Library of Congress, Prints & Photographs Division, 1931 LC-DIG-matpc-22147). The rails are marked by red arrows; (B) from the Petra Hotel roof (April 2011); (B1) dated between 1898-1914 (source: American Colony Photograph Department, Hezekiah Pool, Jerusalem, Jerusalem: G. Eric and Edith Matson Photograph Collection, Library of Congress, Prints & Photographs Division, 1898-1914 LC-DIG-matpc-06560). Neither anchor nor repairs evident in the Catholicon of the church of the Holy Sepulchre (yellow arrow); (B2) originally dated incorrectly to 1900-1920 (source: American Colony Photograph Department, Hezekiah Pool, Jerusalem, Jerusalem: G. Eric and Edith Matson Photograph Collection, Library of Congress, Prints & Photographs Division, 1900-1920 LC-DIG-matpc-00860): The repairs of the Holy Sepulchre are observed as well as the anchor.

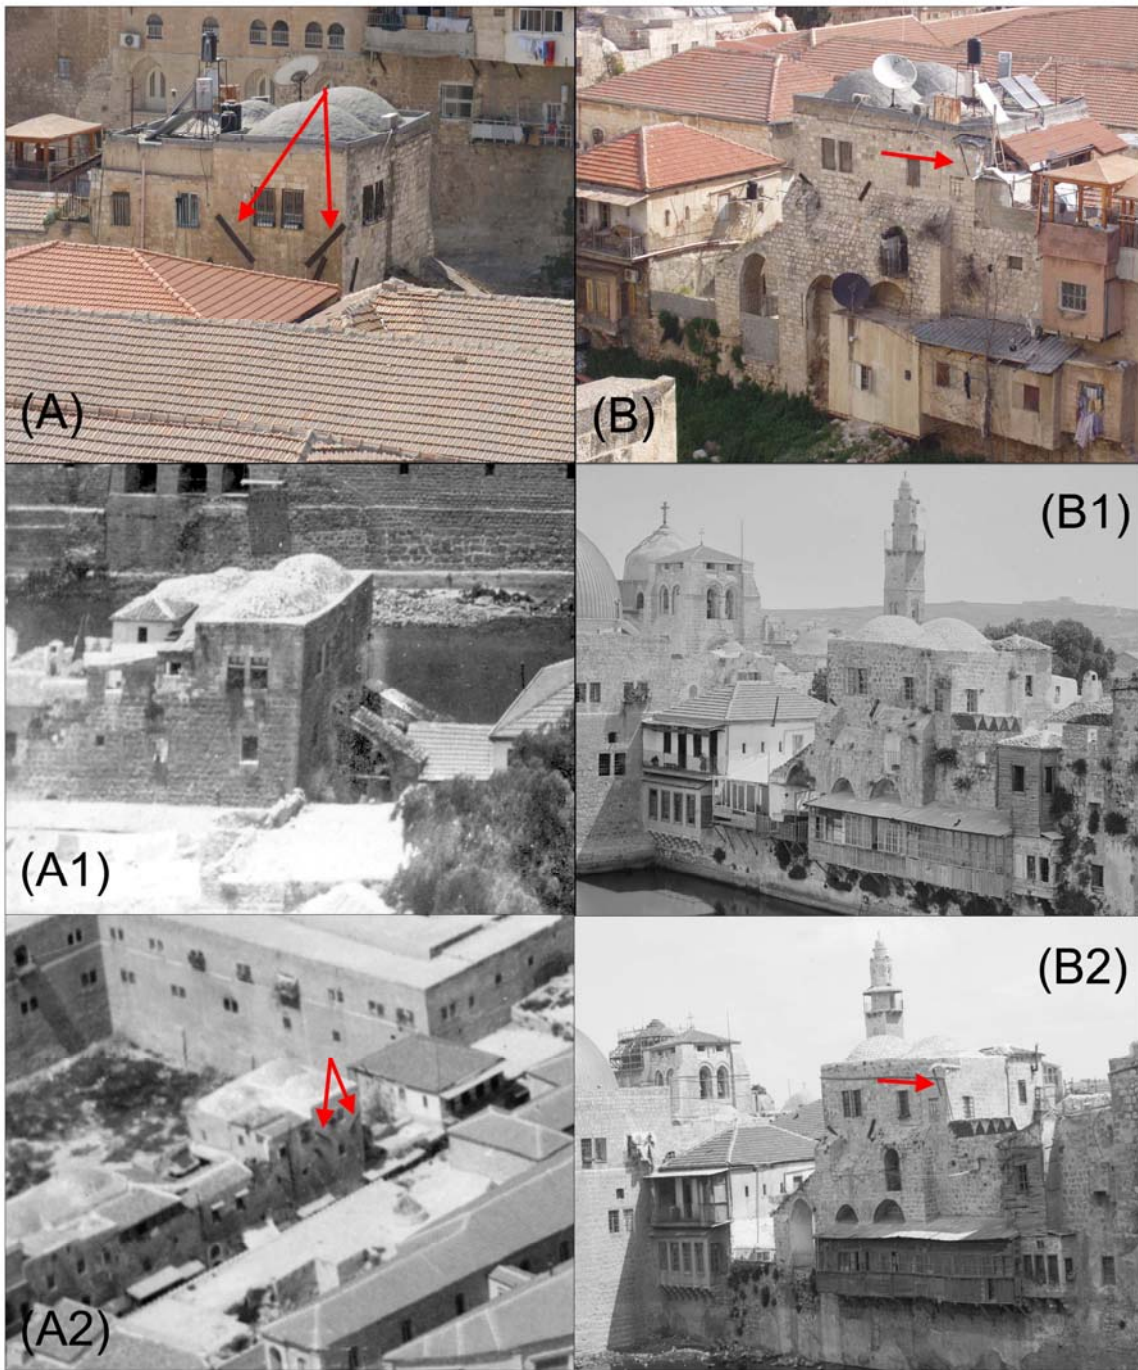
Figure S3

Figure S3: 74 Patriarch Street: (A) contemporary photo taken from the Hotel Petra roof showing three massive iron rails (April 2011); (A1) dated to 1898 (source: Hentschel, B., Panoramic view, Church of the Redeemer, Jerusalem, Leipzig: Yeri Rimon collection, 1898 B. VIII). No anchor is seen in the upper southwest corner. Notice that there are no repairs in the church of the Holy Sepulchre; (A2) air photo from 1931 (source: American Colony Photograph Department, Jerusalem from the air (Old City), Jerusalem: G. Eric and Edith Matson Photograph Collection, Library of Congress, Prints & Photographs Division, 1931 LC-DIG-matpc-22147); (B) the western wall of the building (April 2011). The inspected anchor is marked by red arrow. (B1) an equivalent photo to A1 taken at the end of the 19th century (source: American Colony Photograph Department, Hezekiah Pool, Jerusalem, Jerusalem: G. Eric and Edith Matson Photograph Collection, Library of Congress, Prints & Photographs Division, 1898-1914 LC-DIG-matpc-06560). From this view, one could observe two anchors that were installed prior the earthquake as noted by Michaeli (1928); (B2) dated 1900-1920 (source: American Colony Photograph Department, Hezekiah Pool, Jerusalem, Jerusalem: G. Eric and Edith Matson Photograph Collection, Library of Congress, Prints & Photographs Division, 1900-1920 LC-DIG-matpc-00860). However, the reflected repairs of the Holy Sepulchre imply that the photo was taken after 1927. The inspected anchor appears in the area (noted by red arrow).

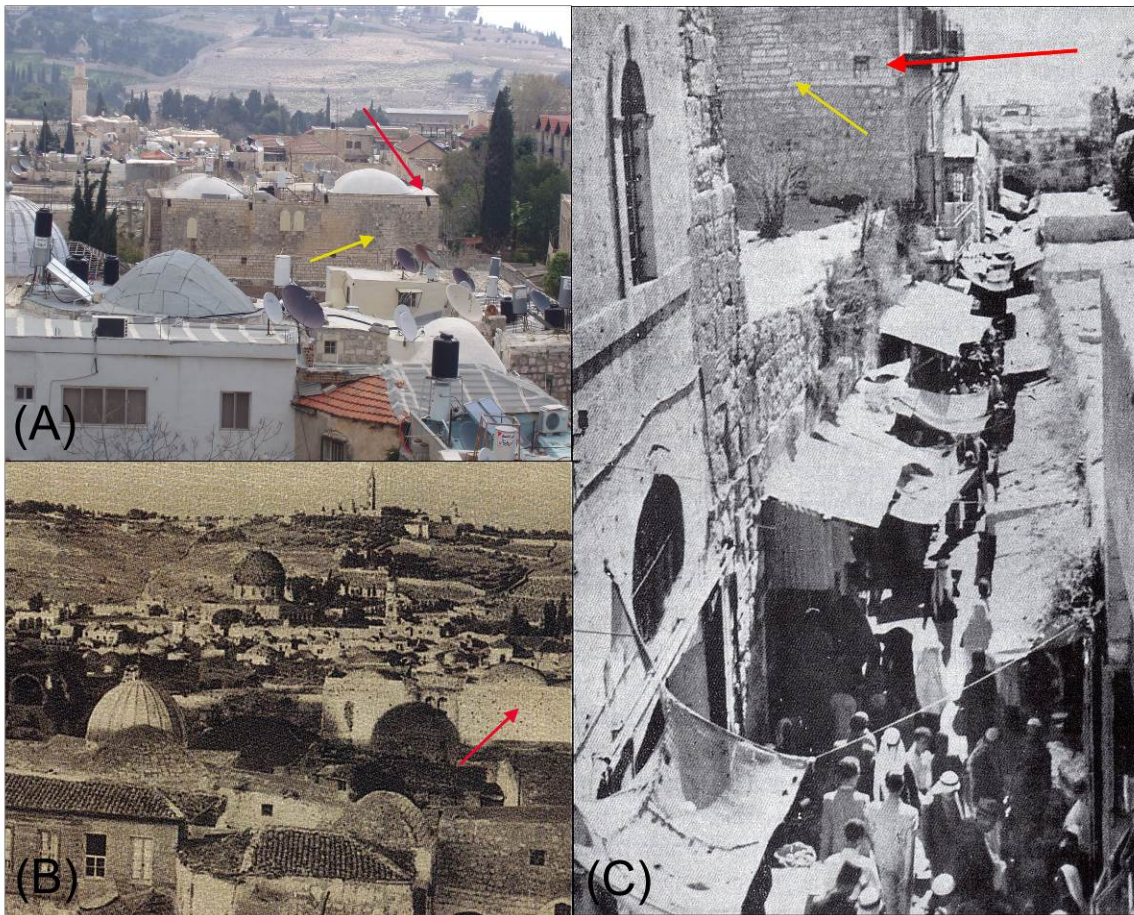
Figure S4

Figure S4: Short iron rails at the Swedish Hostel, David (Bazar) Street: (A) photo from April 2011. Rails (red arrow) and tracks of repairs (yellow arrow) appear on the western wall; (B) at the beginning of the 20th century. The wall (red arrow) is anchor free; (C) in 1937: rails and tracks of repairs appear on the wall (source for B and C: Zacharia, S., 2002. Jewish merchants and craftsmen in the Old City of Jerusalem in the past, Jerusalem: Zur-Ott Press).
