## Earthquake Damage and Repair: New Evidence from Jerusalem on the 1927 Jericho Earthquake

by Motti Zohar, Rehav Rubin, and Amos Salamon

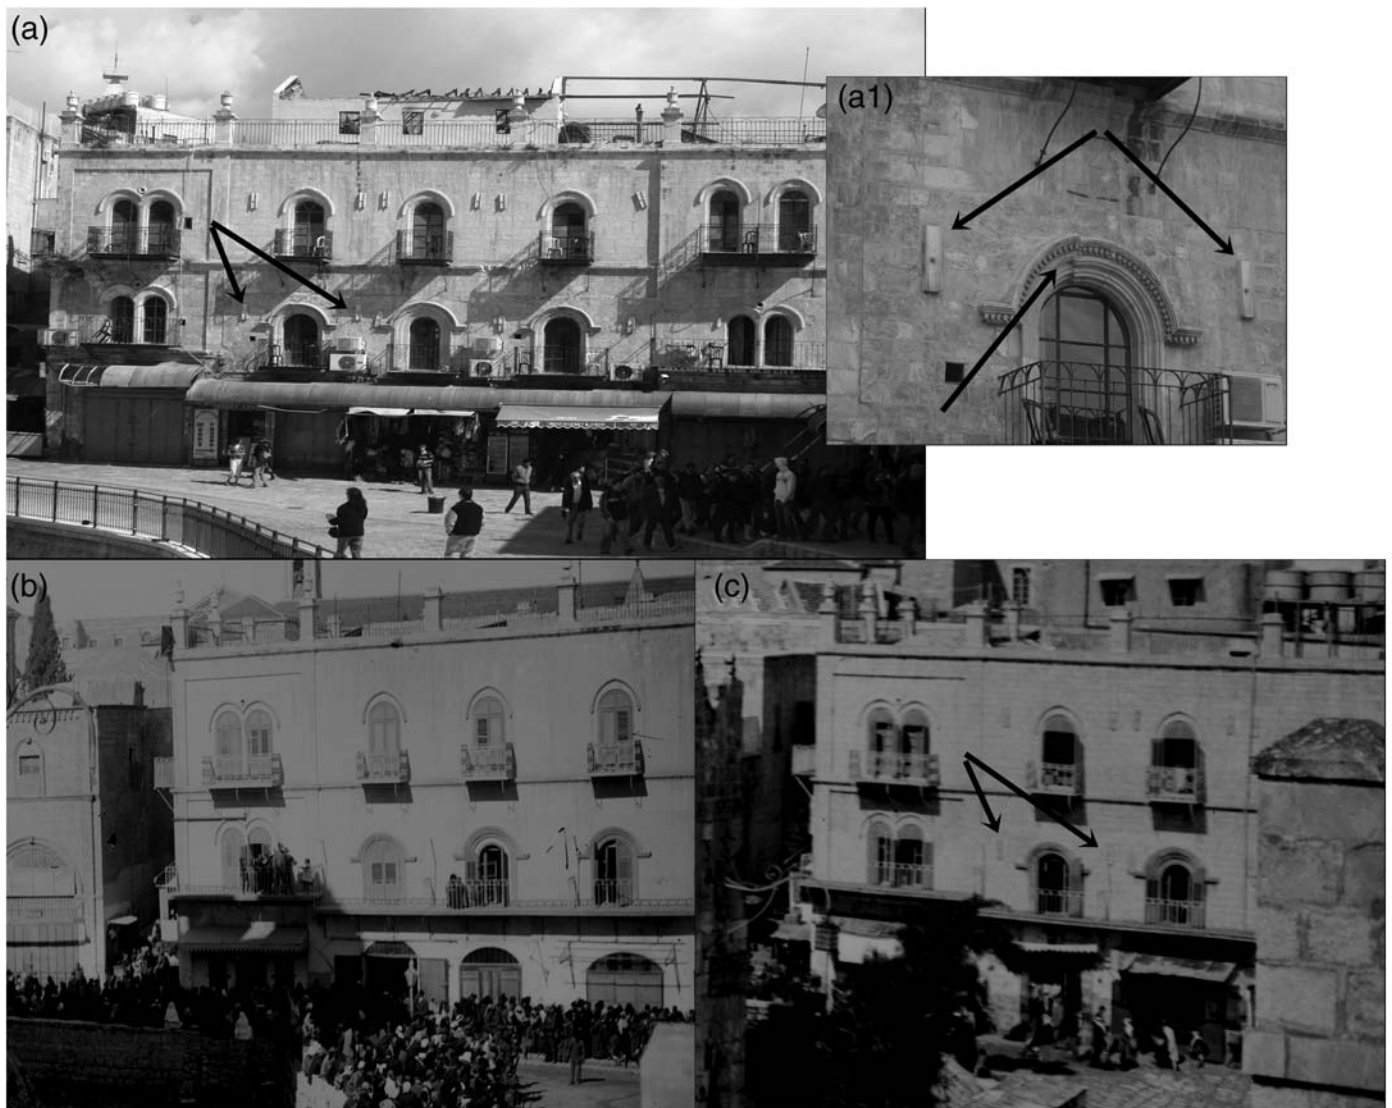
Facing south, the façade of the Petra Hotel (Fig. 1, locality J1) contains 12 massive iron rails located on the second and third floors (Fig. 4). These rails are made of massive steel, pressed inward into the wall by a single hexagonal screw with both sides of the rails covered by poor raw cement. Noticeable cracks

occur on the second floor of the building, in particular above the western window. This impressive building was constructed during the 1840s by Joseph Amzalaq, a Jewish merchant from Gibraltar, but was sold later to the Greek Orthodox Patriarch (Kark and Glass, 1993). At the beginning of the twentieth century, it housed the Central Hotel, also known as the Amdursky Hotel (Zuta and Suckenic, 1920). After the earthquake, local newspapers reported that the building was damaged during the seismic event (Anonymous, 1927b,e). A photograph of the structure dated 11 December 1917 and documenting a proclamation by General Allenby contains neither installed rails nor observable cracks. On the other hand, in a photo dated between 1934 and 1939, rails above the balconies at the second and third floors are seen in the exact positions they are in today. The crack above the western window on the second floor can also be observed clearly in the 1934–1939 photos (Fig. 4).

▲ **Figure 4.** Petra (Amdursky) Hotel: (a) present-day façade: 12 white massive iron rails identified on the second and third floors. A noticeable crack is seen above the window on the second floor (see arrows in magnified image). (b) December 1917, during the proclamation of General Allenby (reprinted from American Colony Photograph Department, Allenby's proclamation being read, Jerusalem; G. Eric and Edith Matson Photograph Collection, Library of Congress, Prints & Photographs Division, 1917, LC-DIG-matpc-08011). The front wall of the hotel does not exhibit any apparatus or cracks. (c) After 1934 (reprinted from American Colony Photograph Department, *The Towers of David & Hippicus*, Jerusalem; G. Eric and Edith Matson Photograph Collection, Library of Congress, Prints & Photographs Division, 1934-1939b LC-DIG-matpc-00448). The iron rails are clearly observed.

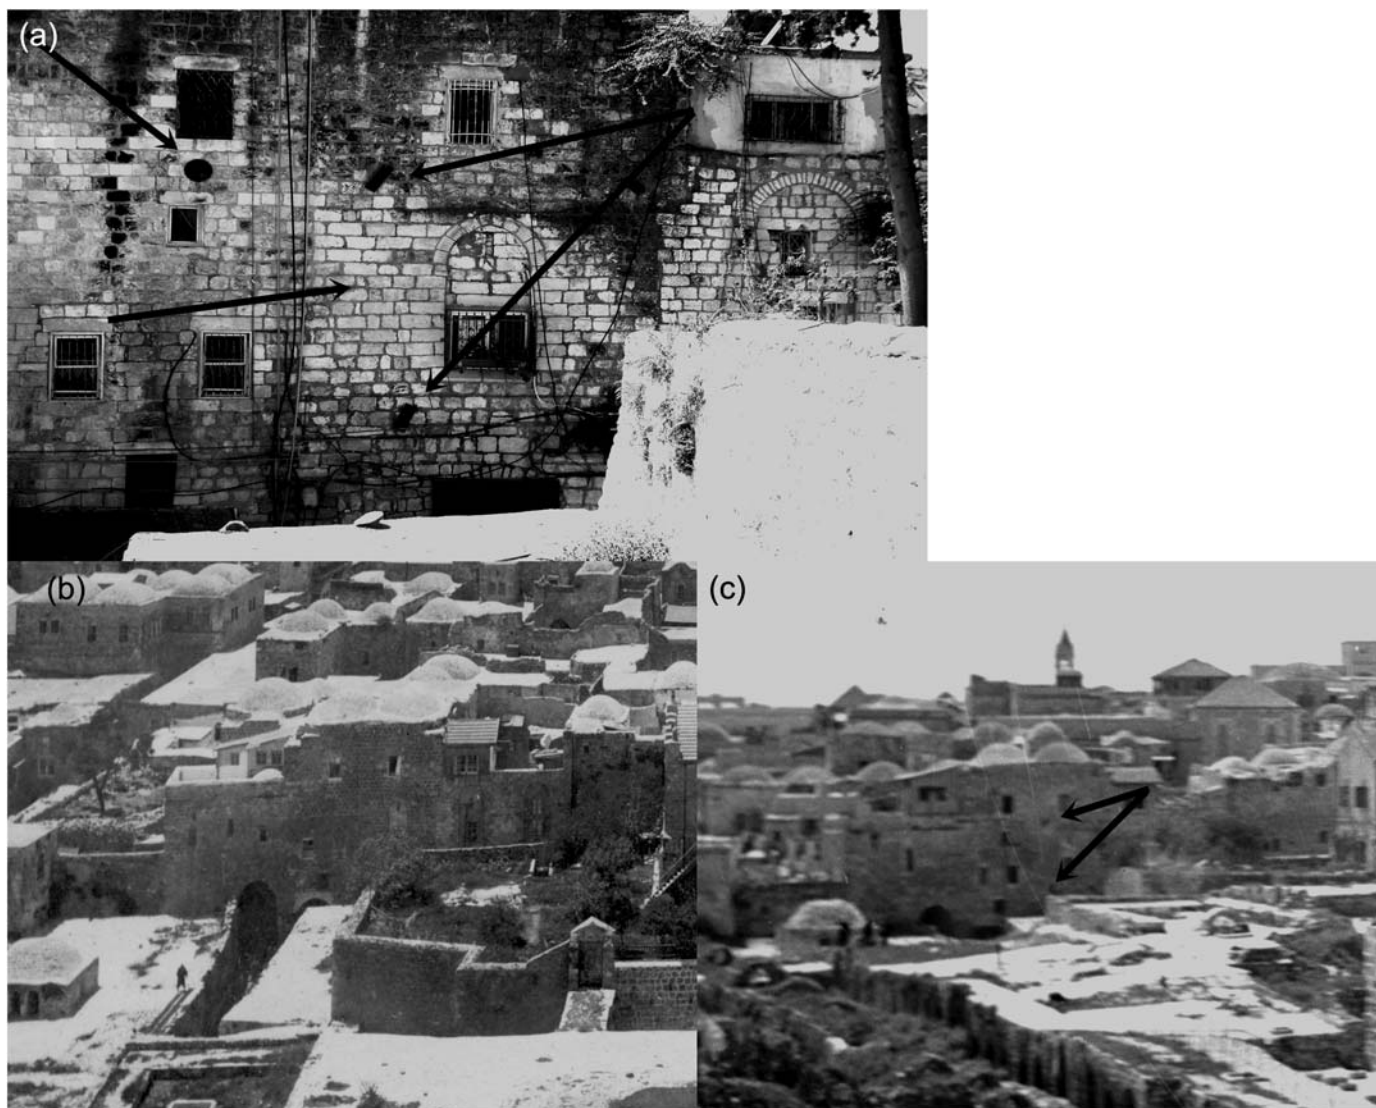
Over the southern wall of a building located at the corner of Saint Mark and Jewish streets, a cluster of four short iron rails surrounds a replacement of the wall's building stones (Fig. 1,

locality J2), implying that part of the wall had collapsed and new stones were inserted to fill the gap. No record of damage in this area due to the earthquake was found in the written sources. However, inspection of two old photographs, both taken from the vicinity of the Church of the Redeemer, shows that the short rails appeared in this wall only in the later photograph dated between 1934 and 1939, whereas they are not found in the first photo dated from 1898 (Fig. 5).

▲ **Figure 5.** The corner of Saint James and HaYehudim Streets: (a) current status (April 2011): both short rails and round clamps (see arrows) over the wall are visible. In addition, cracks are apparent in the same wall (marked by an arrow). (b) From the Church of the Redeemer, 1898, neither anchors nor cracks are visible (reprinted with permission from B. Hentschel, Panoramic view, Church of the Redeemer, Jerusalem, Leipzig: Yeri Rimon Collection, 1898 B. VIII). (c) Dated between 1934 and 1939 (reprinted from American Colony Photograph Department, Old City, Jerusalem, Jerusalem: G. Eric and Edith Matson photograph collection, Library of Congress, Prints & Photographs Division, 1934–1939 LC-DIG-MATPC-17817). Note that the round clamps do not appear.

These relatively well-decorated round clamps were detected in two localities within our research area. Next to the short iron rails at Saint Mark Street, three round clamps are also seen (Fig. 1, locality J6). Theoretically, the fact that both anchor types surround the same fissure might imply they were installed together, but scrutiny of the photographs rejects this and confirms that the round clamps were installed a few decades after the event (Fig. 5). Another pair of round clamps is installed at

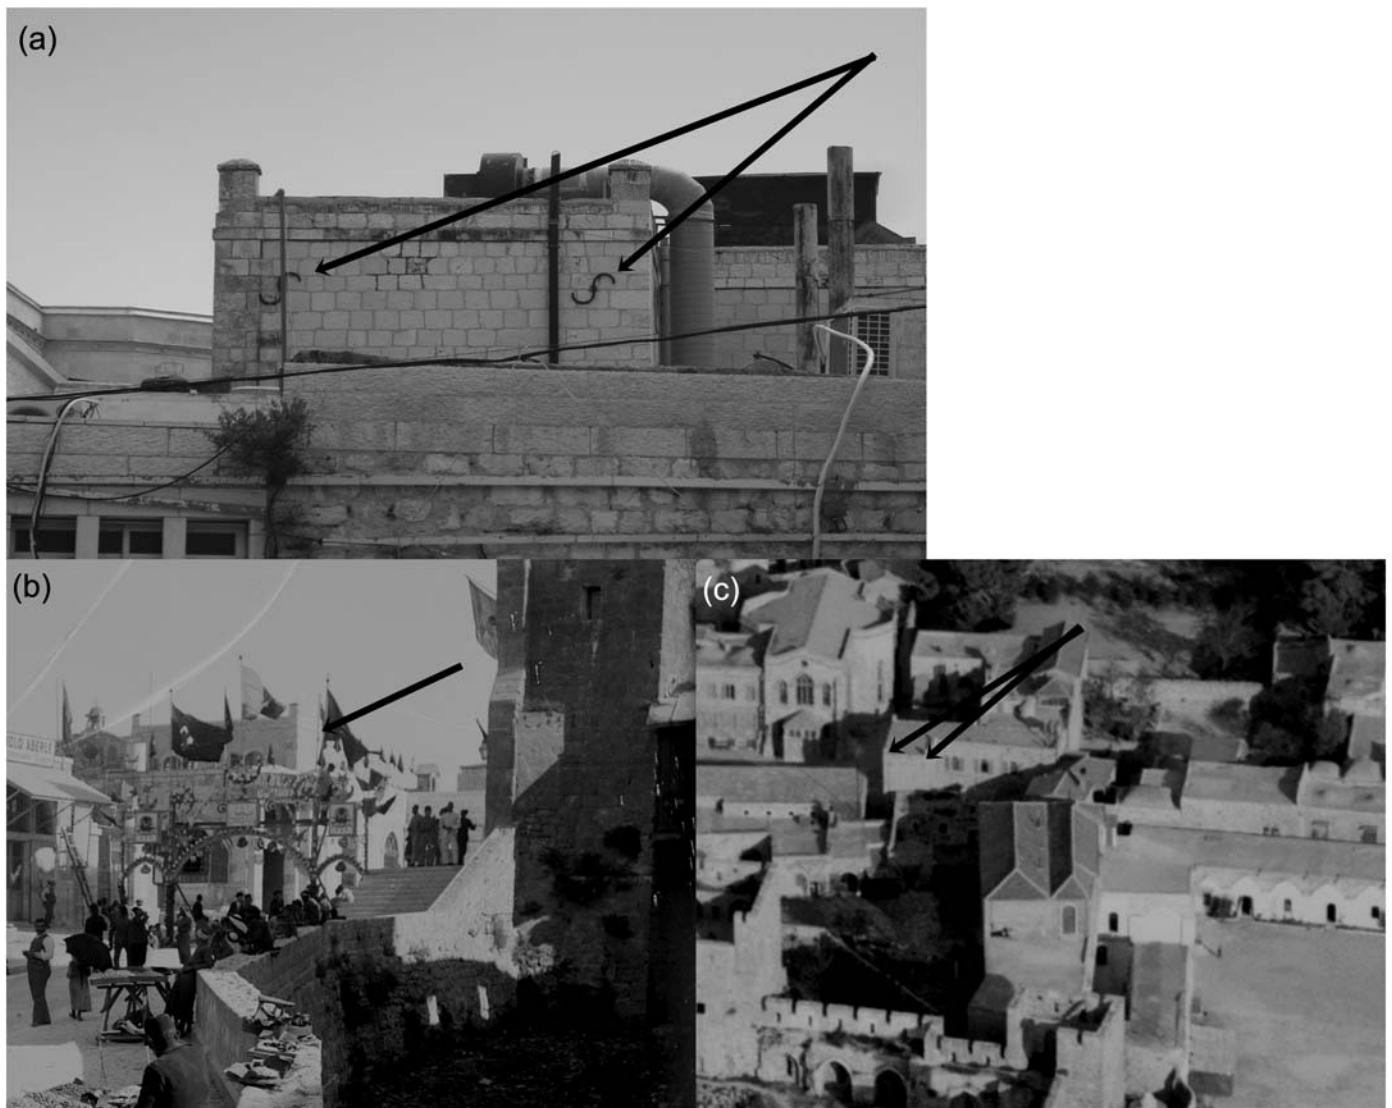
sioner at Christ Church taken in 1931 reveals a black X-shaped anchor. A similar phenomenon is observed on the Alexander building. The S-shaped anchors appear on the western wall in an air photo from 1931, whereas beforehand there were no signs of them (Fig. 8).

▲ **Figure 8.** S-shaped anchors on the Alexander building, Christ Church: (a) April 2011, facing west toward the David Tower. (b) Jaffa Gate area (reprinted from American Colony Photograph Department, moat around the Tower of David, Jerusalem; G. Eric and Edith Matson Photograph Collection, Library of Congress, Prints & Photographs Division, 1898–1946 LC-DIG-matpc-08547). The date of the photograph is vague. The wooden cabinet at the entrance to the David Tower that was removed before 1925 implies, however, that the photograph was taken prior to the earthquake. (c) Air photo of the area from 1931 (reprinted from American Colony Photograph Department, Air views of Palestine. Jerusalem from the air (Old City). Jaffa Gate and Citadel, looking east along David Street, Jerusalem; G. Eric and Edith Matson Photograph Collection, Library of Congress, Prints & Photographs Division, 1931 LC-DIG-matpc-22146). The two S-shaped anchors are marked by arrows.
